**Flood Control Project Maintenance
Levee Inspections**
LMA District Cover Sheet
Spring 2020 Levee Inspection Results

Reclamation District No. 2094 Walthall

Levee Inspection Report By Mile - Spring 2020

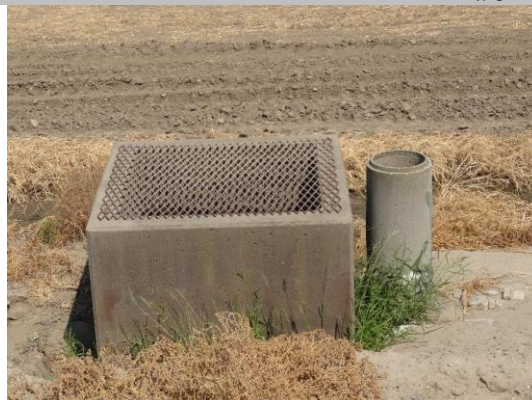
Photo 2 of 3 : UCIP_SP_2020_21545_36528.jpg

LM Start	2.45	Rating **	M	Issue No.	16
LM End	2.45	Issue Type +	En	Location *	
Category	Supplemental			GPS Latitude/Longitude	
				Start	End
Item	DWR UCIP Field Study			37.752308 °	37.752308 °
				-121.293191 °	-121.293191 °
DWR ID	23089				
Comment Code					
Inspector Comment					
DS_ID:23089					
FS_ID:21545					
EP_NO: N/A					
Repair Type: Non-Urgent					
Crossing Status: Found					
UCIP Comments: - no pipes found on either side of the levee.-					
concrete distribution box on LS. Soil erosion around distrinction box.					
FIELD_STRUCT_DESC: Rectangular concrete distribution box on the					
landward toe					
FS Date: 9/10/2013

LM Start	2.45	Rating **	M	Issue No.	16 (cont)
LM End	2.45	Issue Type +	En	Location *
